Case study comparison of maintenance approaches in three Nigerian theatres: Lessons for future design

World Journal of Advanced Research and Reviews, 2025, 27(01), 2745-2760

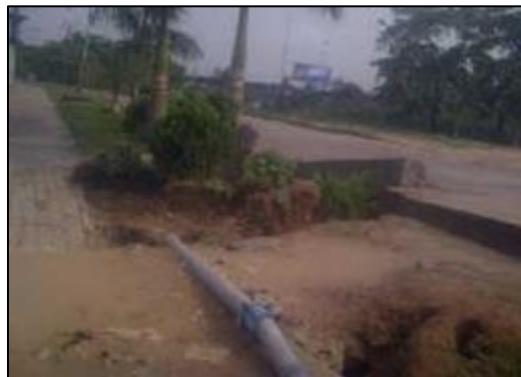
Extensive hard and soft landscaping elements were part of the National Theatre's site planning. In a variety of access zones, compact concrete pavements and interlocking tiles were used for these parts, which marked their sustainability and minimized the need for frequent surface maintenance. However, the site displayed poor drainage as shown in Figure 1, which led to ponding, particularly after rain, contributing to the degradation of paved surfaces and increasing the cost of landscape maintenance.

Figure 1 Poor drainage resulting in the separation and disjoint of access route

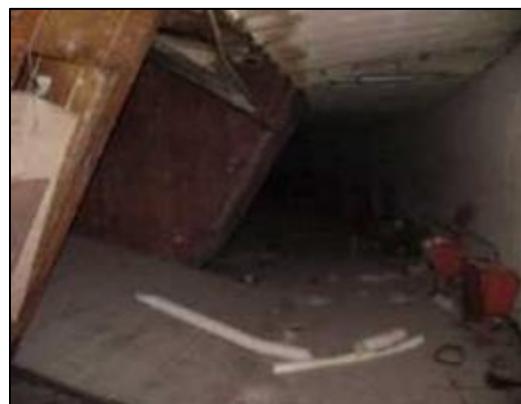
The theatre adopts a radial plan consisting of a central performance zone, around which the various support spaces radiate. Although the major entrance and circulation cores were well-formed, the internal plan has several functional "dead zones", small and poorly defined spaces that encourage neglect and probably vandalism [Figure 2].

Figure 2 Poor state of maintenance within dead zones at the National Art Theatre, Lagos. [Source: Author's survey, 2014]

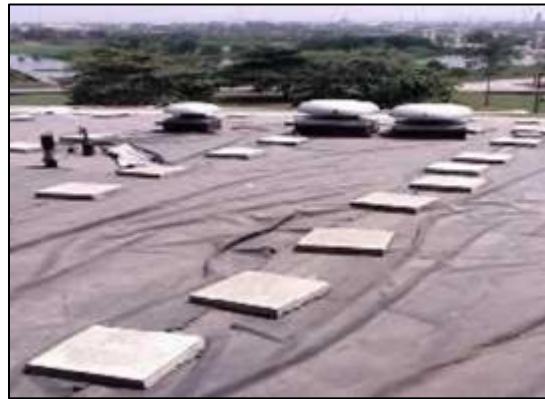
The National Theatre is a brutalist concrete structure best known for its floating curved roof and monolithic appearance. The materials are precast concrete panels, marble floor finishes, and wooden decorative elements. The use of concrete is, no doubt, a durable option; however, many joints are affected by water infiltration resulting from poor detailing and flat roof design, causing wear to structures and degradation of ceilings (Figure 3).

Figure 3 Covering of roof felts with damp proof membrane due to high rate of leakages

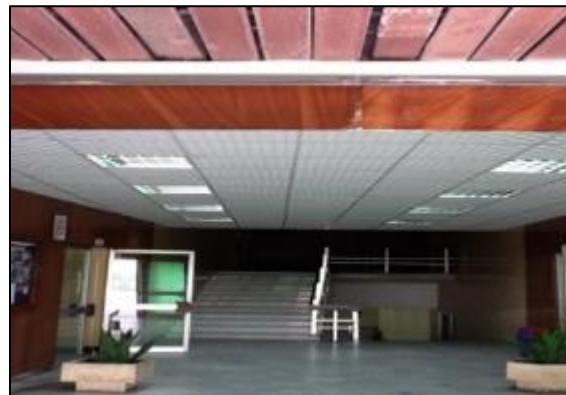
Ideally the roof was a high-pitch slope that would drain better [30], but instead the roof includes flat with complex profiles that collect water, causing leaks and damage. Ceiling boards and exterior paints, for example, have had to be replaced more than once owing to flaking and decay as indicated in Figure 4, which suggests either poor initial selection of materials or an environmental incompatibility. This is indicative of [27] and [32] worries on material properties not being aligned with the demands of the environment.

Figure 4 Replacement of ceiling materials as a result of degradations

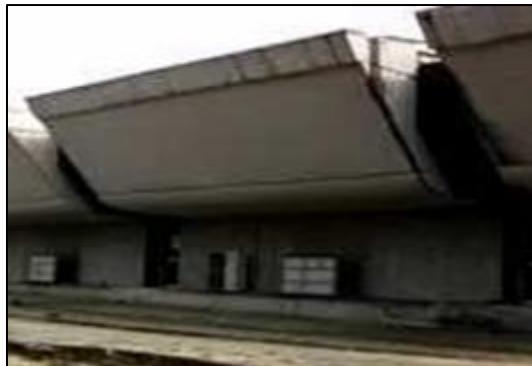
Inadequate drainage around the building and on the roof, leading to water accumulation and structural damage [Figure 5].

Figure 5 The deterioration of exterior walling material

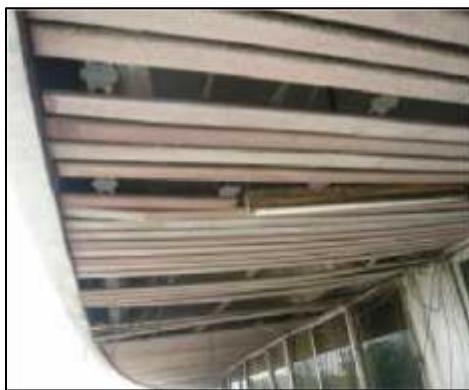
Material failures due to environmental exposure, such as sun-induced fading, rain damage, and corrosion, particularly affecting ceiling boards, external wall paint, and wooden decoration [Figure 6].

Figure 6 Damaged suspended ceiling rails with visible rust

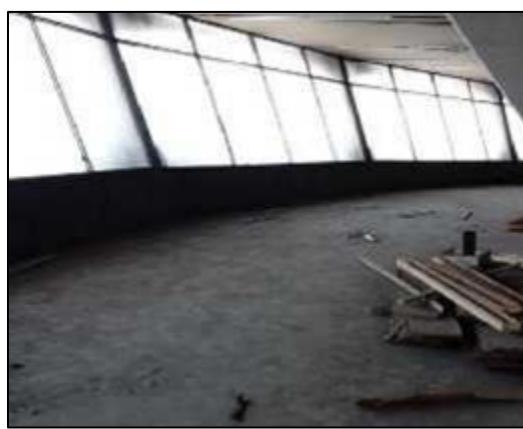
Neglect of non-utilised zones, which become dumping grounds or decay hotspots [Figure 6].

Figure 7 Poor state of maintenance within dead zones

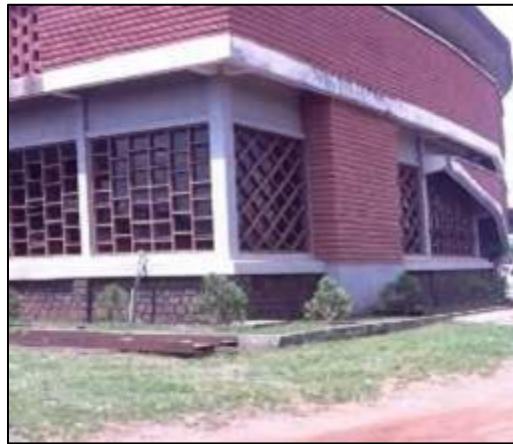
The Oba Akenzua Cultural Centre was designed with relatively serviceable architecture; detailing of open ceilings and cantilevered facades to avoid direct solar gains (Figure 8). The spatial organization is simple, with a clear separation between service and performance areas. Yet, aspects of the centre, particularly façades and rooflines, are vulnerable to the weather, suggesting failings in climatic responsiveness, despite façade cantilevers.

Figure 8 Display of some of the building materials used

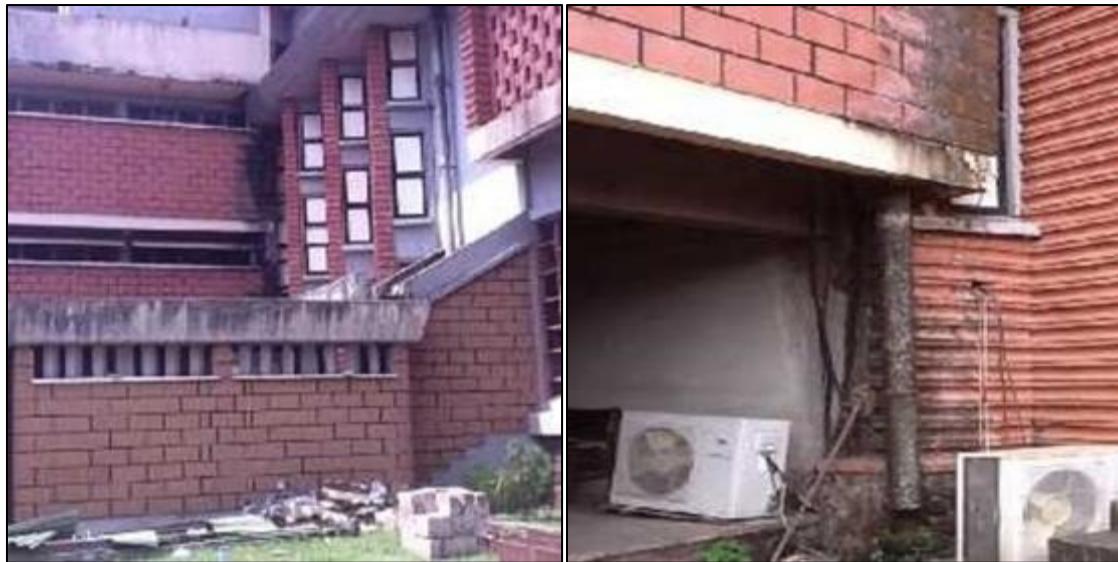
The Oba Akenzua Centre has faced major obstacles in drainage and roof design. Even though drainage pipes can be found at various sites, roof leakages are still significant [Figure 9], which indicates that detailing might be improper, or slope design was not sufficient, as pointed out by [3]. They avoided complex roof geometry, but even the simplified roofscape still didn't encourage effective shedding of water.

Figure 9 Deterioration of walling material

These shortcomings indeed confirm the doubts mentioned by [15,28] stressing the importance of proper architectural detailing particularly roof-water discharge. Rainwater accumulation and intrusion are also strong indicators of inadequate pitch gradients or inadequate drainage.

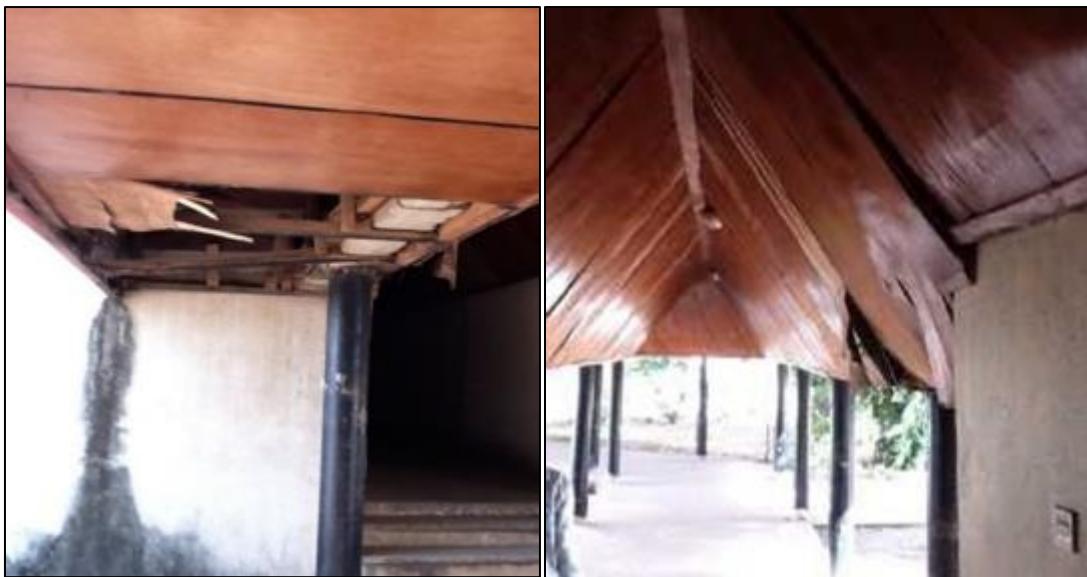
The theatre has likely experienced significant wear-and-tear over its many structural and aesthetic elements. A major concern observed is the flaking and peeling of paints on walls, especially around areas that were previously persistently leaked about due to entry of moisture and poor waterproofing detailing as shown in Figure 10.

Figure 10 Deterioration of some areas within the theatre

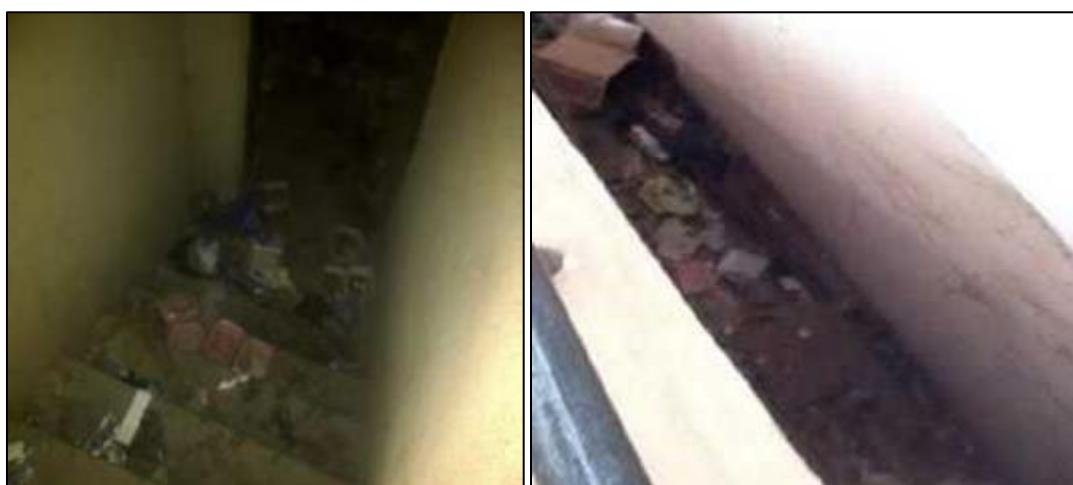
The design of dead zones and also the non-utilized areas give room for poor maintenance practice and vandalistic attitudes by users as reflected in Figure 11

Figure 11 Poor maintenance of nonutilized and dead spaces

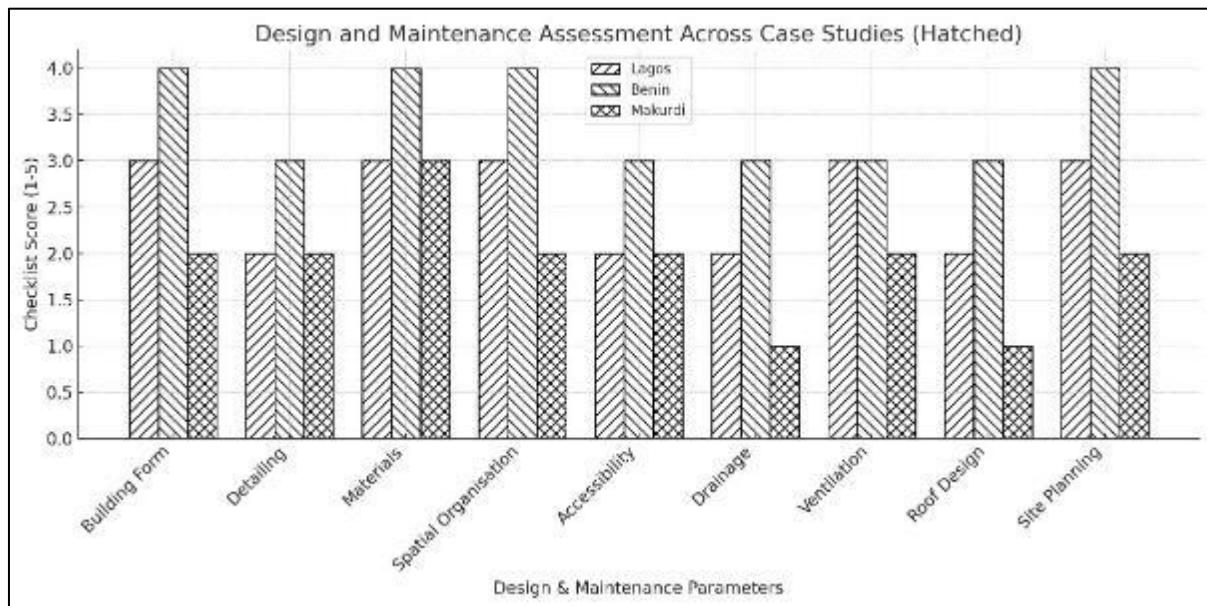
Analysing the three case studies; National Theatre Lagos, Oba Akenzua Cultural Centre Benin, Aminu Isa Kontagora Theatre Makurdi, and comparative study elicits common trend(s) as to emergence and handling of architectural design maintenance challenges as shown in Figure 12 below. While each of the theatres has its own specific contextual and architectural conditions, a number of cross-cutting themes arise that build an evidence-based argument for the deep connection between design decisions and long-term building performance.

Figure 12 Comparative analysis of the three theatres using various parameters
